**Flood Control Project Maintenance
Levee Inspections****LMA District Cover Sheet****Spring 2011 Levee Inspection Results****Sacramento Maintenance Yard East Levee Yolo Bypass**

Levee Inspection Report By Mile - Spring 2011

Waterway						Bank	Unit Miles	Inspection Start/End	Inspector
Unit No. 01 Yolo Bypass						Left	2.00	03/07/2011 03/07/2011	John Williamson

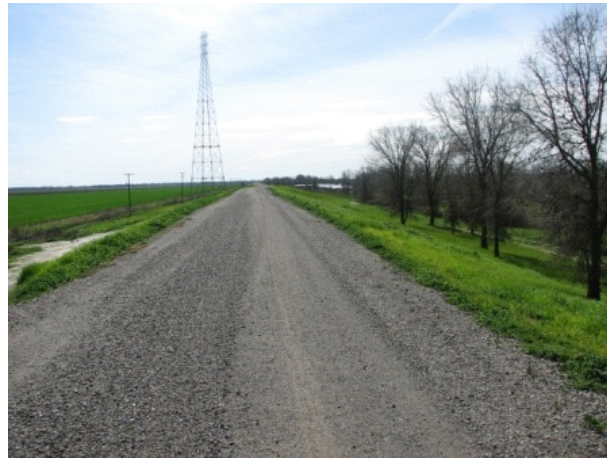
johngw_s_20110307_343.jpg

Levee Mile Report Line	2
Start Levee Mile	0.14
End Levee Mile	0.14
Location	Water Side
Category	Earthen Levee
Item	Vegetation

The grasses are acceptable on both sides of the levee. 3-7-11

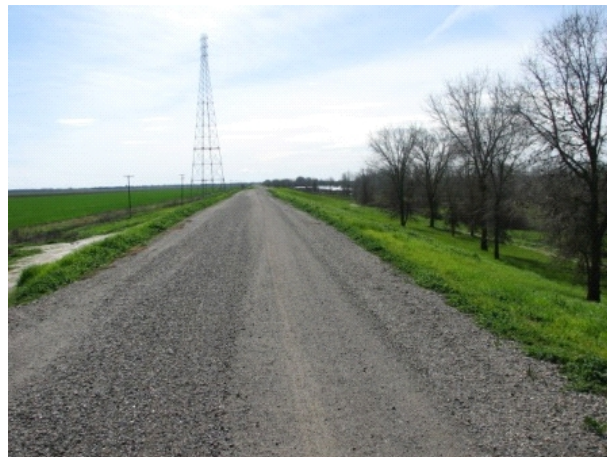
johngw_s_20110307_344.jpg

Levee Mile Report Line	3
Start Levee Mile	0.14
End Levee Mile	0.14
Location	Land Side
Category	Earthen Levee
Item	Vegetation

The grasses are acceptable. 3-7-11

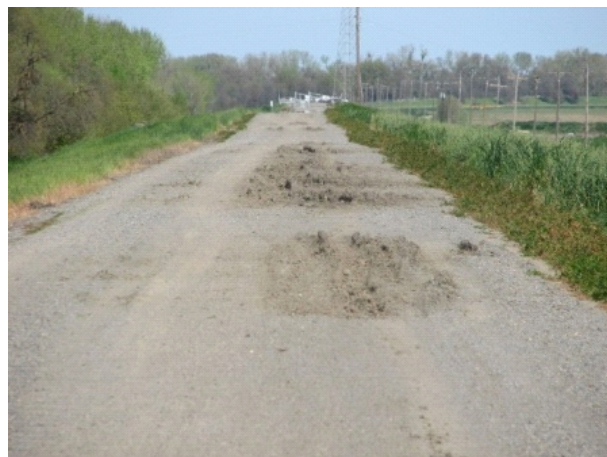
johngw_s_20110228_282.jpg

Levee Mile Report Line	4
Start Levee Mile	1.64
End Levee Mile	2.00
Location	Crown
Category	Earthen Levee
Item	Crown Surface / Depressions / Rutting

Regrade the crown and add AB for an all weather surface.

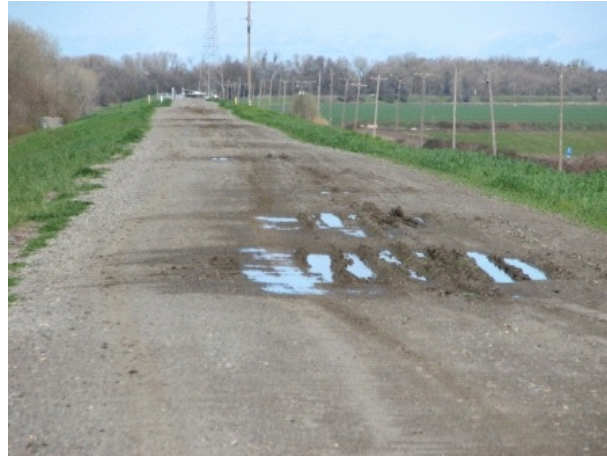
Levee Mile Report Line	4
Start Levee Mile	1.64
End Levee Mile	2.00
Location	Crown
Category	Earthen Levee
Item	Crown Surface / Depressions / Rutting
The crown of the levee needs to have AB added for an all weather levee. 3-7-11	
johngw_s_20110307_345.jpg
